Internal fatigue crack initiation in drawn Ti-6Al-4V wires

J. Everaerts, B. Verlinden, M. Wevers

Abstract

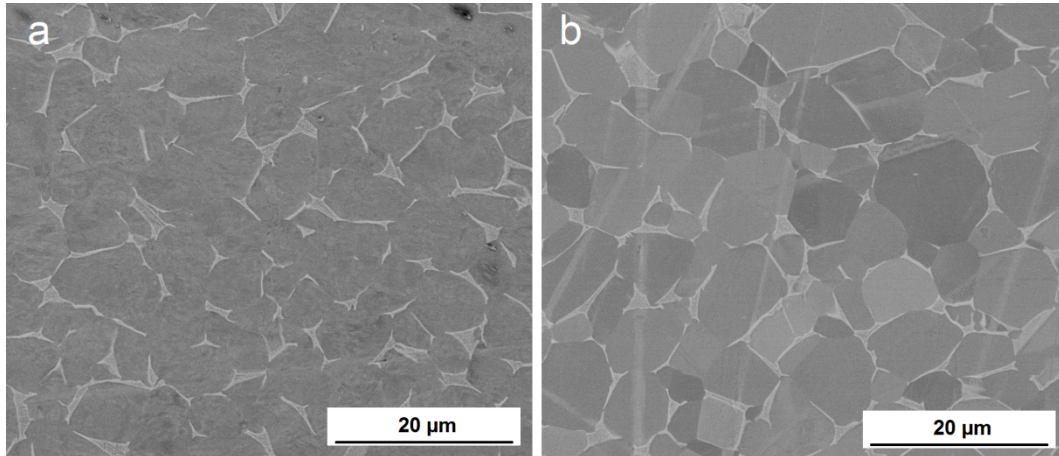
Figure 1: Backscattered electron images of the Ti-6Al-4V wire; a cross-section; b longitudinal section

partially transformed β (bcc) at the grain boundaries, as can be seen in the backscattered electron image of the cross-section and longitudinal section of the wire (Figure 1). The average α grain size is approximately 5 μm , as calculated from an EBSD measurement.

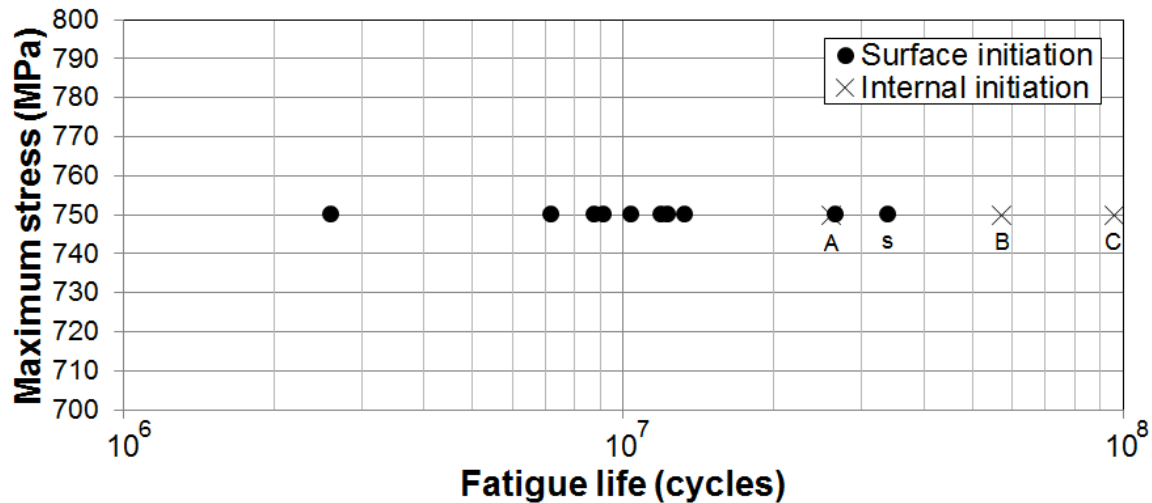
Figure 3: Fatigue life variability of Ti-6Al-4V, showing samples with surface and internal initiation

Figure 3 shows the fatigue life as a function of maximum applied stress for all samples that failed within the gauge section. Samples that failed inside the clamps have been omitted from this graph. Although the maximum stress is the same for all samples, it is clear that there is a rather large variability in the fatigue life. This spread of almost two orders of magnitude is not uncommon for the Ti-6Al-4V alloy^{7, 8, 11, 35} and in this case can be explained by the fact that the applied stress level is chosen to be close to the transition point from surface to interior initiation, the so-called “knee” in the S-N curve.^{13, 14, 21} In fact, three samples have failed as a result of internal crack development, marked as samples A, B and C in Figure 3. It should be noted that there is no well-defined transition from surface to internal initiation in terms of fatigue life. There are two samples with surface-initiated failure, for example sample ‘s’, with a higher fatigue life than sample A.

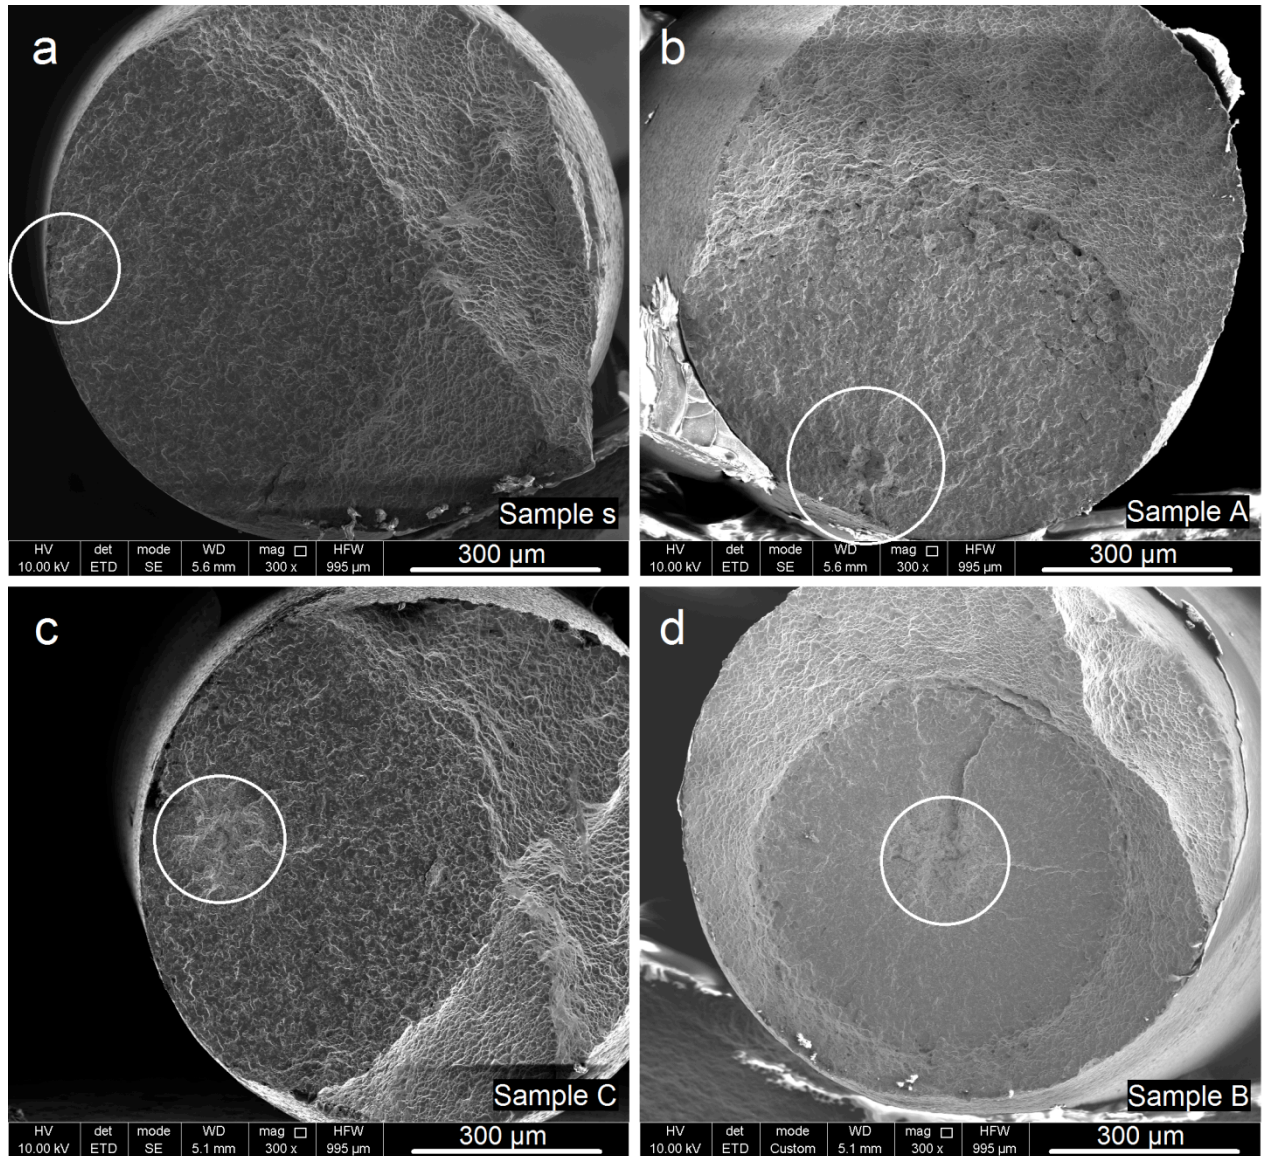
Figure 4: SEM fractographs at 300x magnification of four samples, white circles indicate the initiation area; a 3.4×10^7 cycles to failure (sample s); b 2.6×10^7 cycles to failure (sample A); c 9.6×10^7 cycles to failure (sample C); d 5.7×10^7 cycles to failure (sample B)

SEM fractographs of the fracture surfaces of four samples at a low magnification are shown in Figure 4. A typical example of a surface-initiated failure can be seen in Figure 4a (sample s), whilst Figure 4b and Figure 4c show two samples that failed due to subsurface-initiated cracks (samples A and C, respectively). The fractograph in Figure 4d shows sample B, which failed due to internal crack initiation, forming a so-called 'fish-eye' fracture surface, which has a rough central crack initiation area, surrounded by a circular internal crack growth area. It should be noted that the fatigue life of the subsurface-initiated sample C in Figure 4c, 9.6×10^7 cycles, is higher than the fatigue life of sample B with the fish-eye failure in Figure 4d, 5.7×10^7 cycles, even though the latter has a crack initiation location which lies further away from the sample surface. This is in accordance with the findings of Yokoyama et al.,²⁰ who concluded that the fatigue life does not correlate with the location of the internal crack initiation site.

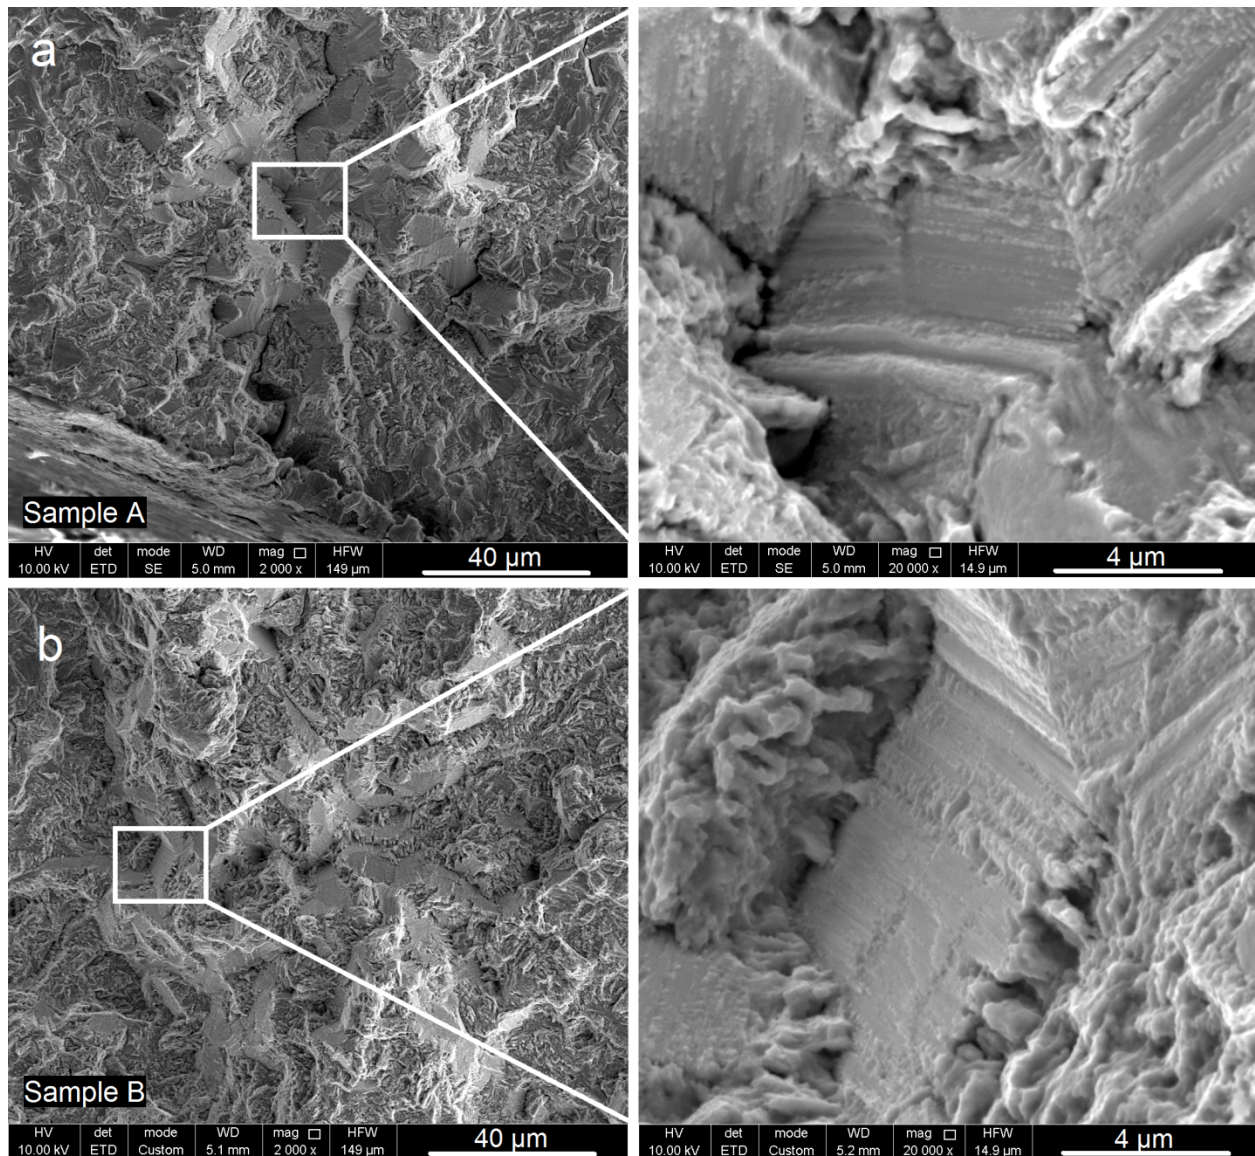
Figure 5: SEM fractographs at 2000x and 20 000x magnification of two selected samples; a 2.6×10^7 cycles to failure (sample A, subsurface); b 5.7×10^7 cycles to failure (sample B, fish-eye)

The samples in Figure 4b (A, subsurface initiation) and Figure 4d (B, fish-eye) are selected for a more detailed fractographic analysis. For both samples, the initiation area is found to contain many facets, as is shown in Figure 5. Both fracture surfaces have approximately 50 individual facets each. At higher magnification, it becomes clear that the facets on the fracture surfaces are not smooth, but instead display markings or some roughness on the nano-scale. As stated in the introduction, only a few publications mention the presence of markings on the facets, either in the form of a radial pattern^{4, 14, 26}, or as a slip-like pattern in a Ti-22V-4Al alloy.²⁸ In this case, the markings are not radial, but instead are more linear, which suggests that they could be slip traces.

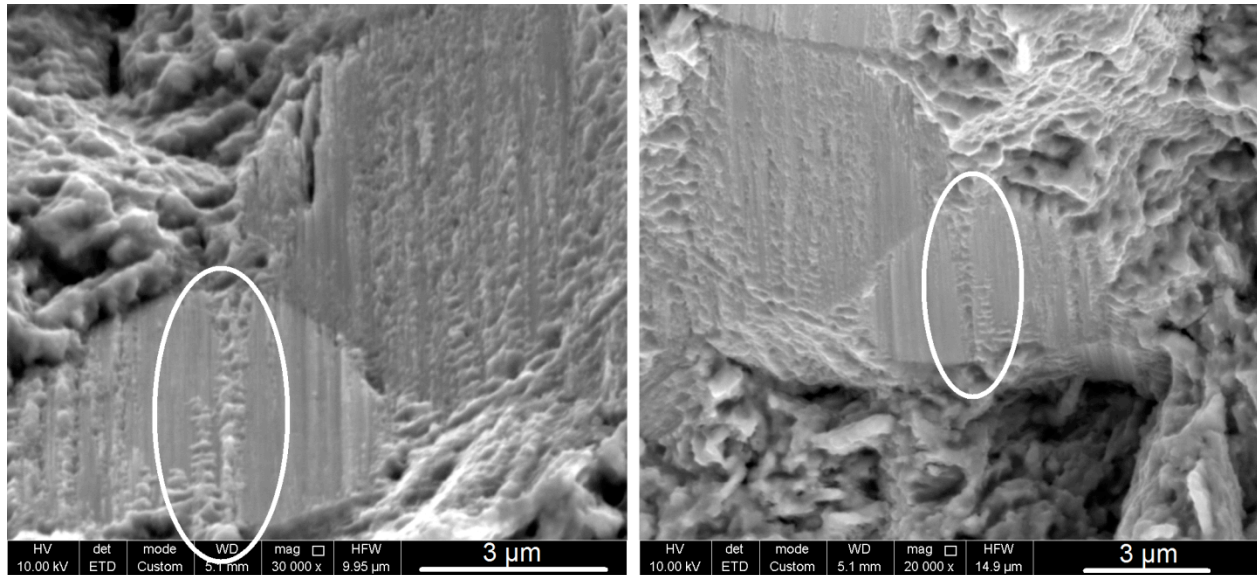
Figure 6: SEM fractographs of sample B (5.7×10^7 cycles to failure), taken at the same location on both opposite fracture surfaces (left and right)

However, some of the nano-roughness features deviate from the linear pattern, as can be seen for example in Figure 6. The two images in this figure are taken from both opposite fracture surfaces of sample B, at the same location. The white ellipse indicates a non-linear marking on a facet. Interestingly, on one fracture surface it appears that the pattern consists of material on top of the facet (Figure 6 left), whilst on the opposing fracture surface the same pattern appears to be pressed into the facet (Figure 6 right), which suggests that some material was transferred between the two opposing crack surfaces. The appearance of these markings and the apparent material transfer between both sides of the fracture surface draws similarities with galling and cold welding patterns seen in adhesive wear. The presence of a wear mechanism during internal

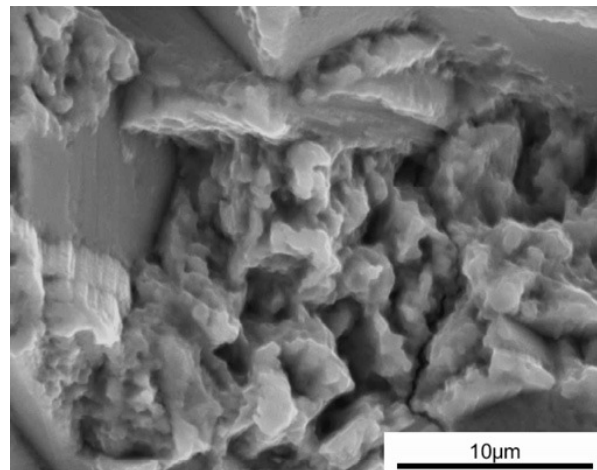
Figure 7: Rounded fractographic features on the fracture surface of a subsurface-initiated Ti-6Al-4V sample³⁶

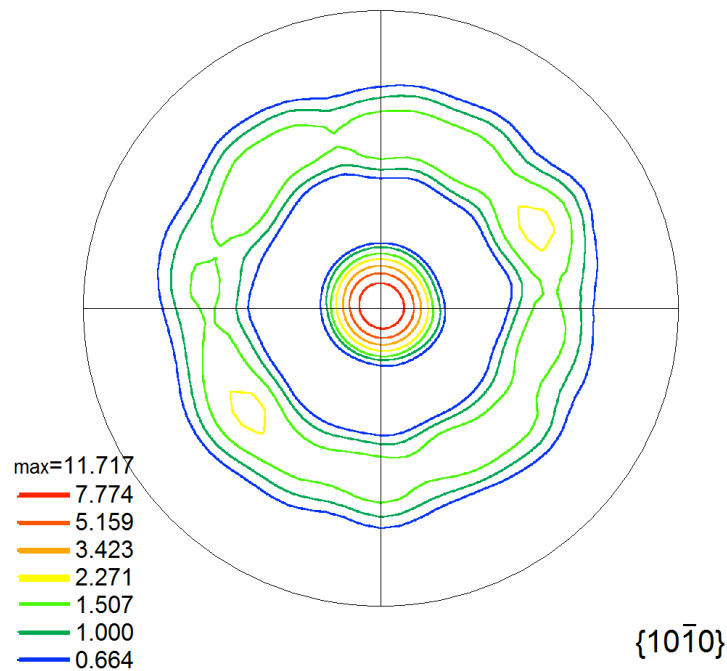
Figure 8: $\{10\bar{1}0\}$ pole figure of alpha phase, obtained from an EBSD measurement on sample cross-section, wire axis is perpendicular to the paper

crystallographic texture of the alpha phase, which is different for the wire-drawn samples in this study compared to the forged rods used in other studies. It has been reported that facets are parallel to certain crystallographic planes, in most cases the basal plane^{7, 12, 27, 32, 37, 38} or the prismatic plane,^{7, 27} which means that the spatial angles of the facet planes are linked to the texture. The alpha phase texture of the wire used in this study is shown in Figure 8. It can be seen that there is a high tendency for grains to be oriented with the normal direction of the $\{10\bar{1}0\}$ planes parallel to the wire axis, as well as a tendency for grains to be oriented with the normal direction of the $\{10\bar{1}0\}$ planes rotated approximately 60° from the wire axis. The spatial angle distribution of the facets on the fracture surfaces of the selected fish-eye (B) and subsurface (A) sample is shown in Figure 9. It is noted that this distribution is very similar for both samples, which further insinuates that the facet formation mechanism is related to the crystallographic texture. The spatial angles of facets in these samples deviate from the facet angles found in similar publications. Jha et al.⁷ reported that the majority of facet angles for a fish-eye sample were between 30° and 60° , while Bantounas et al.³⁸ found that the angles of initiation facets for a subsurface-initiated sample were between 15° and 40° . These angles are considerably smaller than those found in this work.

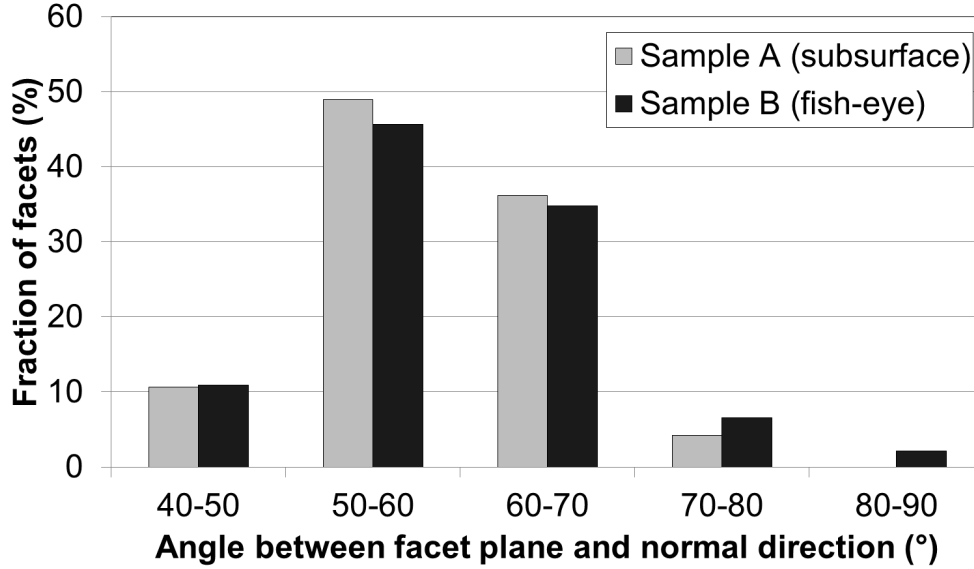
Figure 9: Distribution of spatial angle of facets (between facet plane and normal direction) for both sample A (subsurface, 2.6×10^7 cycles to failure) and sample B (fish-eye, 5.7×10^7 cycles to failure)

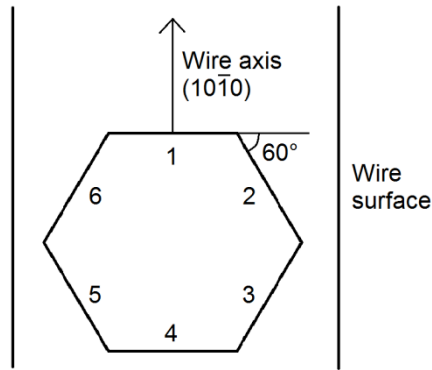
Figure 10: Representation of crystal orientation present in the texture of the wire, and the six prismatic planes of the hexagonal lattice

If the markings on the facets are indeed the result of a local internal wear process, as suggested by McEvily et al.,¹⁷ then it is clear that the facet angle is an important parameter in this process. Given the fact that the fatigue tests are performed in tension-tension (load ratio of 0.1), a certain amount of crack closure is also required if there is to be contact between two opposing crack surfaces. It is plausible that the specific crystallographic texture of the Ti-6Al-4V wire used in this work has caused the facets to be more inclined with respect to the loading direction, which in turn has resulted in the presence of wear markings on the facets. On the other hand, some of the markings on the facets could simply be slip traces. If it is assumed that the facets are parallel to a certain crystallographic plane, Figure 10 illustrates that in this case it is most likely to be the prismatic plane. This figure shows the orientation of the hexagonal lattice which represents the two most prominent texture features, being the normal direction of the $\{10\bar{1}0\}$ planes parallel to the wire axis, and the normal direction of the $\{10\bar{1}0\}$ planes rotated approximately 60° from the wire axis (see Figure 8). Combined with the fact that most facets lie at an angle of approximately 60° to the normal direction (see Figure 9), it is plausible that they were formed on one of the prismatic planes orientated with the normal direction rotated 60° from the wire axis (see Figure 10, planes 2, 3, 5 and 6). It is interesting to note that in this case no facets have formed on the prismatic planes numbered 1 and 4 in Figure 10, since these would have had an angle of approximately 0° with respect to the normal direction and such angles have not been measured (see Figure 9). Bridier et al.²⁷ also suggested that the mechanism of prismatic crack formation involves slip band formation, while crack formation on the basal plane involves cleavage due to the fact that slip is restricted on this plane. This could explain the fact that the
